Fire Safety Research towards Enabling Timber Structures in Canada

ABSTRACT: In Canada, practitioners are moving beyond the mid-rise timber framed structure and progressing to the design of hi-rises. Examples include the *Brock Commons* building at 18 storeys, *Terrace House* which is planned to have 19 storeys, and the 13 storey *Origine* building. Each building encompasses an integrated usage of (multiple) engineered timbers: Cross-Laminated Timber, Laminated Veneer Lumber, and Glulam timber for example. These designs are being supported by extensive research which examined the fire performance of these aforementioned engineered wood products. While practitioners have begun to build these hi-rise structures in Canada and abroad, there is still much we do not know about these materials and their behavior in fire, as identified by various global research collegiums. This paper will begin with an overview of past and recent published ‘timber in fire’ research conducted in Canada and its relation to global research conducted elsewhere. Emphasis is on the ongoing Canadian research as being conducted by the authors themselves, collaborators and their consultancy partners towards a stro

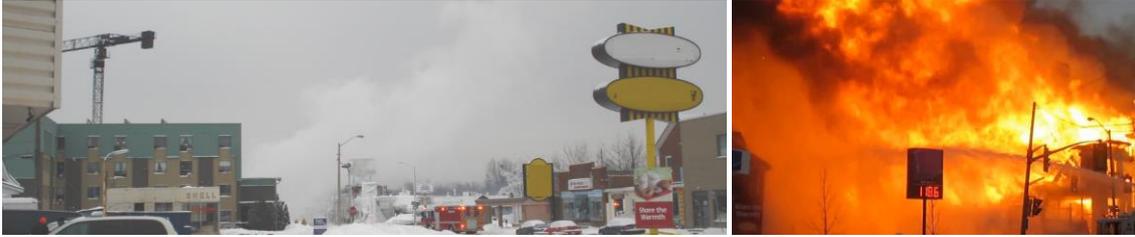
Figure 1. Kingston, Ontario Conflagration of 2013 resulted in closure of the downtown core (authors' photos modified to remove business names).

After the fire, Canadian construction industry began focusing attention to discussing the merits and pitfalls of using timber in general construction with emphasis given to timber’s inherent risks of fire during construction (independent on the differences between light and mass timber). A photo of the site taken by the corresponding author during an investigation visit on December 18th 2013 is provided in Figure 1. This fire began a debate on recent changes in the Canadian building code that were recently promoting mid-rise timber construction.

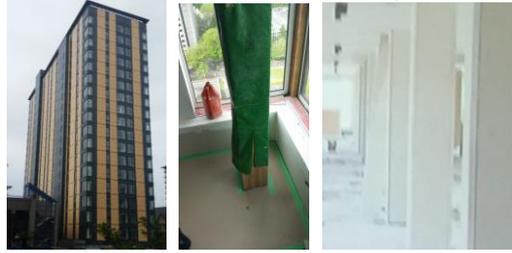
Figure 2. Brock Commons exterior and interior (authors' photos). Multiple layers of gypsum were used on timber columns and slabs in order to facilitate acceptance by building authorities.

Building on the mid-rise momentum and advancements, Canadian and international practitioners are moving beyond the mid-rise timber framed structure and progressing to the design of the hi-rise construction. Canadian examples include the *Brock Commons* building at 18 storeys (see Figure 2), and the 13 storey *Origine* building in Quebec. More recently *Terrace House* has been proposed at 19 storeys, though that will include concrete floors. Each building encompasses an integrated usage of (multiple) engineered timbers: Cross-Laminated Timber (CLT), Laminated Veneer Lumber (LVL), and Glulam timber for example. These designs are being supported by extensive research which examined the fire performance of these aforementioned engineered wood products. In Canada, their facilitation is also being promoted with the flexibility afforded to the alternative solution clauses within the objective-based building code. These structures are all subjected to very significant control during construction to ensure their safety. The Kingston Conflagration, which was of 'light' timber – not engineered – resulted in 22 charges being laid for construction practices, including 12 related to fire safety. Heavier timber elements are known to perform better in fire than their 'light' counterparts. While they can still ignite with heat, because of their remaining cross section after fire they have larger reserve strength. That aspect was prevalent knowledge during the late 19th century in mill construction (see Otto et al., 2017). Engineers intentionally scaled up timber elements for business continuity in the event of a fire. Nevertheless, the distinction between light and heavy timber is significant and is a focus of the developments of research for timber construction in Canada. Proposed

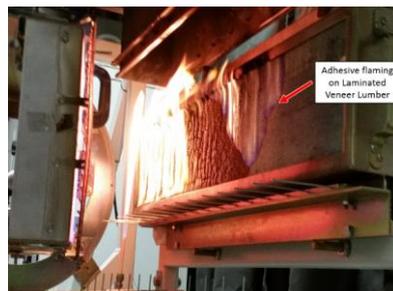
Figure 10. Adhesive bleeding effect in LVL (Otto et al., 2017)

Unique in these material experiments of flame spread was a phenomenon observed in less than 25% of the LVL panel tests. What occurred was, at incision points, a bleeding effect of adhesive appeared to propagate flame spread along the surface of the specimen. Measured charring depths illustrated very little effect from this behavior (see Figure 10).
