PERFORMANCE OF GFRP STAY-IN-PLACE FORMWORK FOR BRIDGE DECKS AFTER REAL AND SIMULATED FIRE DAMAGE

ABSTRACT

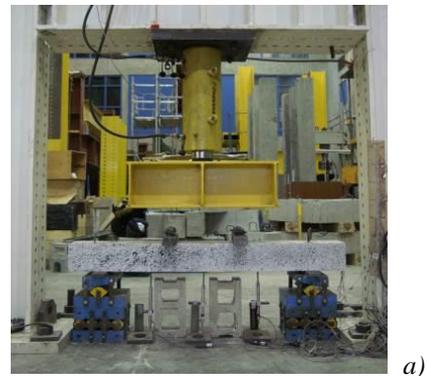
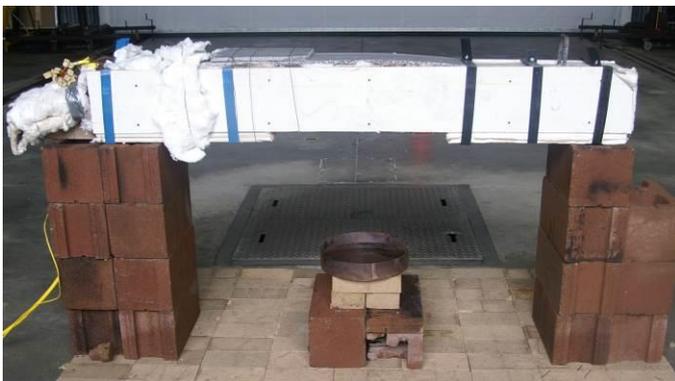
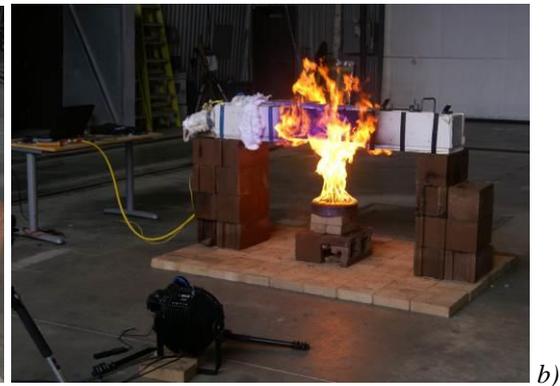
Fig 2. (a) Typical test setup and load configuration (dim in mm); (b) Pool fire burn setup

Each specimen was tested under four-point monotonic loading up to failure. To compare the simulated damage to real fire damage, Specimen FD was exposed to a heptane pool fire for a total burn time of 14 minutes (a typical burn time approximated from other structural testing literature [7][8]). The pool fire had a pan diameter of 30 cm, burned 1.6 litres of heptane, had a continuous flame height of approximately half a meter. It should be noted that this pool fire is not strictly comparable to others as the test scale was small, and the fuel was adjusted to reach a sustained burn for a specific time. A pool fire was utilised as the application of this study is for bridges and this type of fire would be the more realistic exposure expected. The beam was supported 50 cm above the base of the pool fire pan. To precisely control the length of damage inflicted by the fire to the soffit, sections of the strip were covered in two layers of gypsum board. The fire was intended to damage only the moment span region, which would allow a comparison with Specimen SD3. Specimen FD was loaded after heating. Loading while heating was not considered but can have effect on any GFRP while it is being heated beyond glass transition [9]. *Figure 2* below shows a typical loading configuration used to test each strip specimen and the test set up for the pool fire.

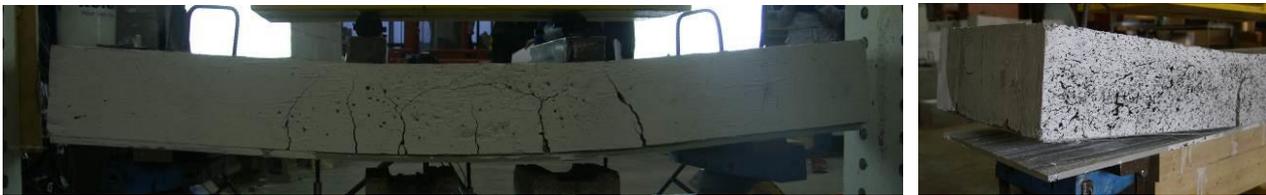
Fig. 5. Specimen C2 crack distribution and GFRP delamination

The undamaged beams experienced significant flexural cracking but despite large crack widths, no concrete portions fell away from the GFRP. *Figure 5* shows the crack pattern and damage sustained by Specimen C2. The bottom GFRP plate was able to hold the fractured chunks of concrete in place as the load shifted to the formwork. This coupled with the additional bond surface area provided by the bottom plate held enough concrete intact to maintain partial composite action between the GFRP and concrete and eventually cause delamination of the GFRP formwork. This failure mechanism was observed in specimens C1 and C2.

Specimen FD experienced similar flexural cracking patterns as Specimen C1/C2 shown in *Figure 5* and also experienced a similar failure mechanism involving loss of composite action and delamination where the bottom plate sheared off of the base of the GFRP rib on approximately one half of the span. Given these results it is believed the amount of fire damage sustained was

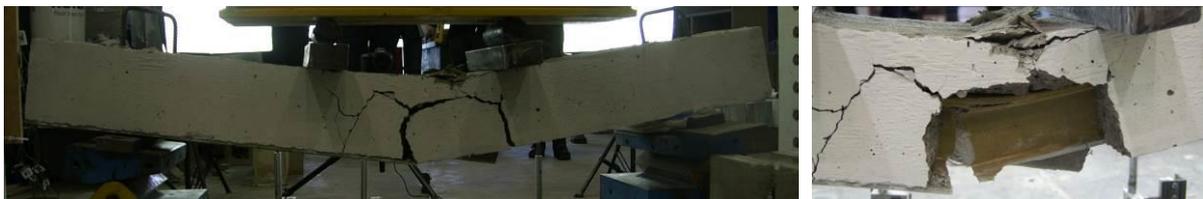
Fig 6. Specimen SD1 crack distribution and GFRP fracture

The primary failure modes observed in the SD tests involved a combination of concrete crushing, GFRP debonding and eventual fracture of the GFRP formwork. *Figure 6* shows the flexural cracking and fracture of the GFRP near the damage boundary. In general, the damaged beams experienced significant flexural cracking in the moment span with the exception of SD3. Slipping between the formwork and the concrete was observed during all stages of each test but compatibility between the members was only severely reduced when flexural cracks were wide enough such that portions of concrete would fall away, exposing the GFRP T-Up rib. At this stage, most of the load was supported only by the formwork and eventually the GFRP section fractured. In tests where the bottom GFRP plate was removed, fracture of the formwork occurred at the boundary where the damaged and undamaged sections of the plate met. This behaviour is characteristic of each damaged strip test.
