An Investigation into the Resilience of Glulam Timber Beams after Fire Exposure

Chorlton, Bronwyn¹, Harun, Georgette¹, Gales, John^{2,5}, Weckman, Elizabeth³ and Smith, Matthew⁴

Abstract: A critical element in the design of timber structures is the building's response in the event of a fire. Currently, engineered timber, which relies on complicated adhesives to join wood elements, is used to build up large section sizes for structural assemblies. When not encapsulated and exposed to fire, however, engineered timber mechanically degrades via charring and adhesive breakdown. Understanding this degradation will provide greater confidence for the practitioner for new tall timber designs since it is necessary to better determine the performance of engineered timber under fire exposure, and also to determine the level of reparability required after a fire. Therefore, the present study examines a hypothetical design example as motivation for research into fire response in tall engineered timber construction. The case study prompts the need for demonstrative testing to build confidence in use of exposed (unencapsulated) timber elements. For this, the after-fire performance of engineered

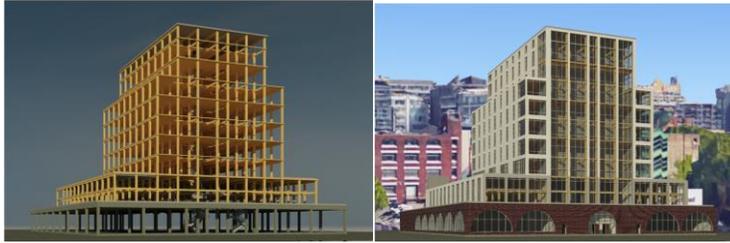
Figure 1: Structure of *Hypothetical A* engineered timber hybrid building (left), and exterior of *Hypothetical A* building (right).

The theoretical structure of *Hypothetical A* can be seen in Figure 1. It is not the intent to provide anything other than a hypothetical rendering of the structure and therefore specific design is omitted. An engineered timber structure can take on many different structural timber configurations. This could, though not limited to, include: Glulam beams and columns, Nail laminated timber slabs, Cross laminated timber cores and partitions. Typical load path configurations in many timber buildings feature a grid shape.

This research was performed utilizing resources from the NSERC Discovery program. The authors wish to thank Adrian Soble for allowing the use of his renderings featured in Figures 1 and 2.
